## Case study

## Traffic management project in Phnom Penh

Seiya Matsuoka

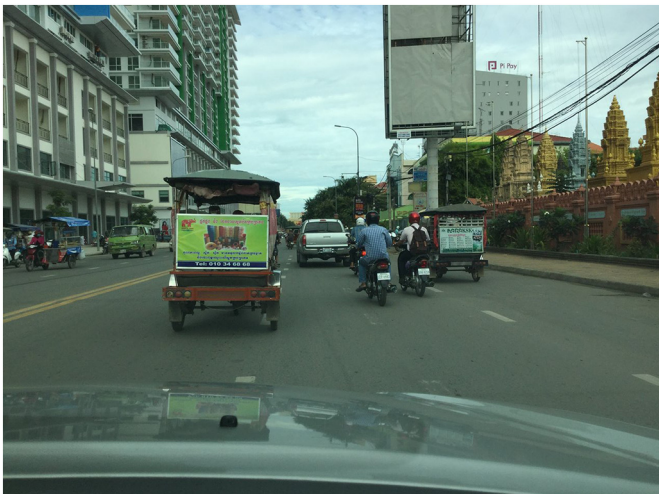
Fig. 1. Tuk-tuk running at road center.

Traffic in Phnom Penh is chaotic, with different types of vehicles from luxurious SUVs to motorcycles and motorcycle-drawn tuk-tuks running on the same road. (See Fig. 1) Of these types of vehicles, the motorcycle is the majority and occupies 70–90% of the traffic volume. Different types of vehicles have different performance and maneuverability, resulting in an inefficient flow and unsafe traffic conditions. The tuk-tuk is a unique type of transport. It is a passenger cart driven by a motorcycle, and a maximum of four passengers can ride on the

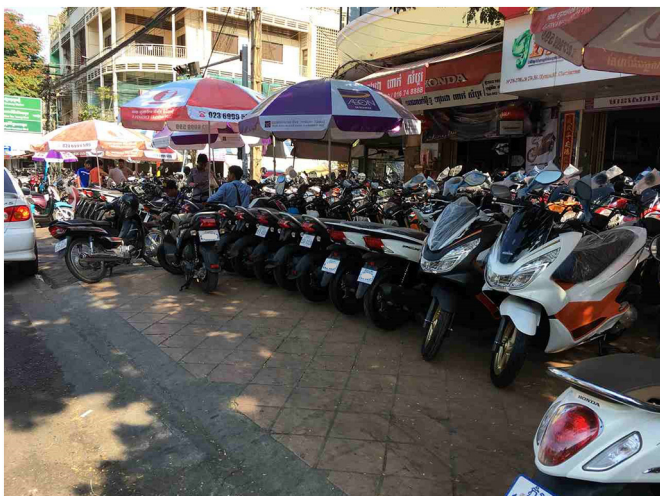
Fig. 3. Motorcycle occupying sidewalk in front of shop.

Another lamentable practice detrimental to the pedestrian environment is the use of shop front as store space. Many shops consider the space in front of their shop as their territory and use it for their business leaving no space for pedestrians (See Fig. 3). The practice not only reduces the road capacity but also endangers the pedestrians as they are forced to walk on the carriageway.

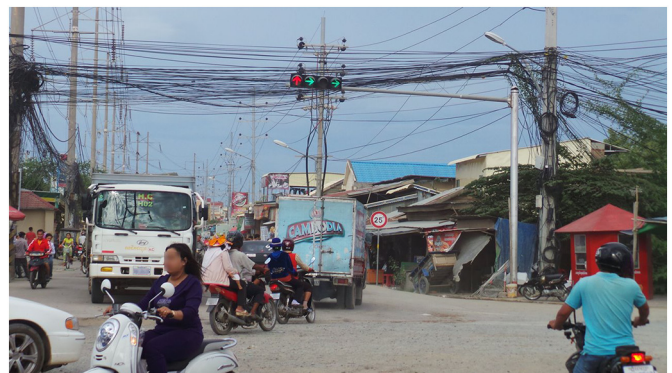
Fig. 4. Old, outdated signal.

Most of the old signals were functioning, but minimal maintenance was conducted by DPWT staff who was not properly trained. The pedestrian lanterns provided to most of the signals were not functioning, as they were disconnected from the controller in all but a few locations. Pedestrians paid no attention to the pedestrian lanterns, and most people did not even know that the lanterns existed. (See Fig. 4).

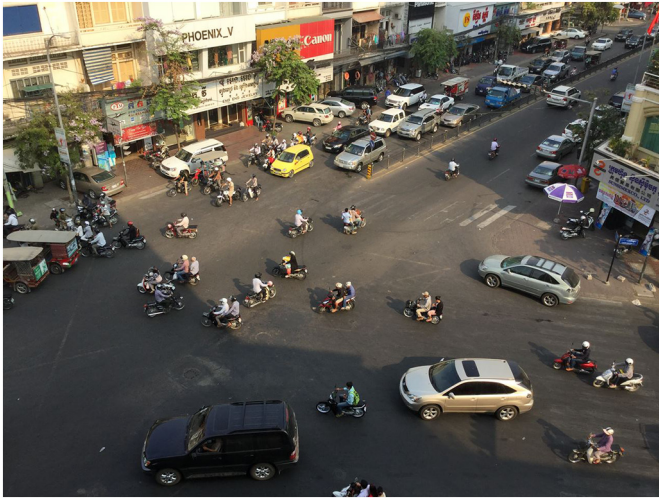
Fig. 5. Unruly status of intersection before project.

Pavement markings, median dividers, traffic signs, and other traffic control devices play an important role in traffic management. They regulate the traffic flow and prevent accidents. Although these devices existed before the project, they were not properly installed based on traffic engineering considerations. Moreover, many of these devices were dilapidated or worn out, and were not performing their functions. (See Fig. 5).

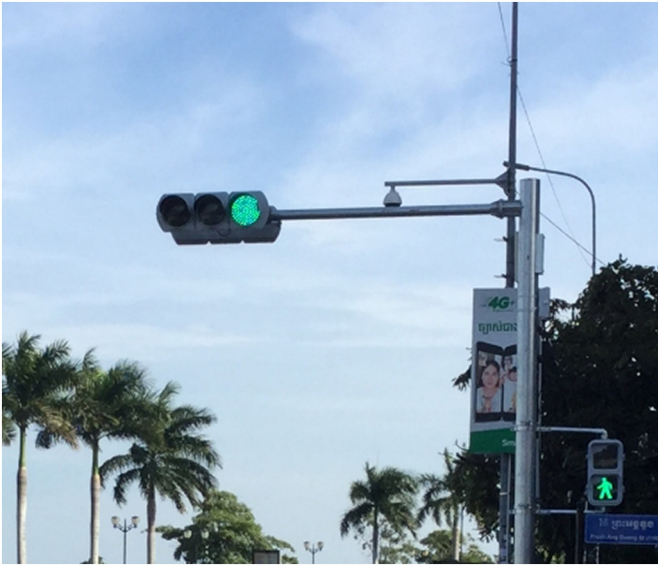
Fig. 9. Newly installed signal.

In the old signal system, only one set of lanterns was placed for each movement, and the lanterns sometimes malfunctioned or were not bright enough. In the new system, two sets of high-brightness lanterns, including arrow lanterns, are used for each movement to make the signal more conspicuous and effective. (See Figs. 9 and 10).

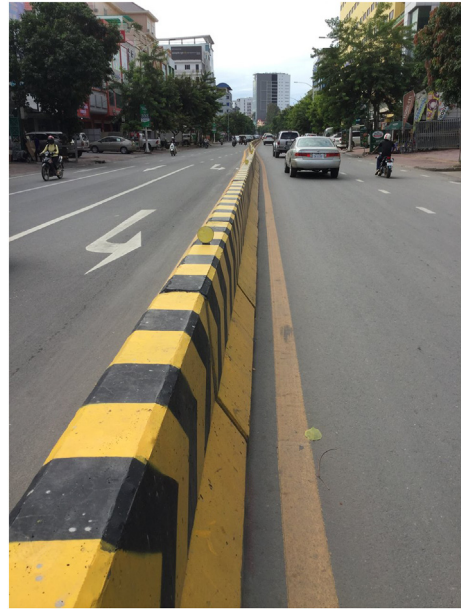
Fig. 11. Median divider.

A median divider is a physical block that prevents vehicles and pedestrians from crossing. Previously, different types of median dividers (steel fence, low concrete block, and high concrete block) were used without rules. Only high concrete block is used by the project, with some exceptional cases for narrow roads. Sections covered by a divider are extended to an entire section between two signalized intersections in some sections to prevent motorcycles from moving to the wrong side of the road, which was often observed in the past. The layout of the median divider was reviewed and adjusted in conjunction with the pavement marking design. (See Fig. 11).

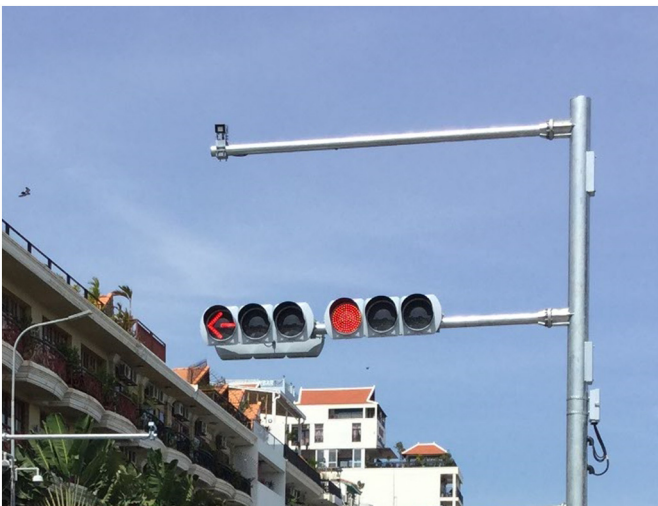
Fig. 10. Newly installed signal with video vehicle detector above.

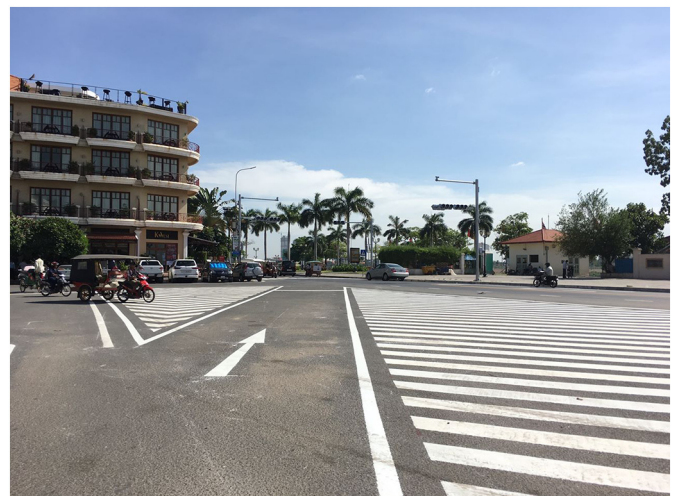
Fig. 12. Pavement markings.

The project included the renewal of pavement markings with new layouts. First, design standards were established such as the lane width, location and size of pedestrian crossing, length of additional left turn lane, and location and type of arrow symbols. (See Fig. 12).
